Transition/Reserve Study for

Roxborough Reserve

Philadelphia, PA

November 30, 2021

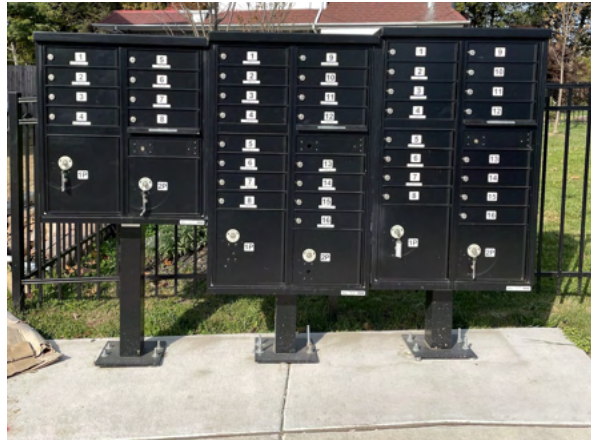
Mailboxes - raised mounting bolts

- Three mailbox pedestal kiosks are present at the entrance to the property. The mounting bolts securing the kiosks to the concrete pad should be cut and ground smooth prior to developer turnover.

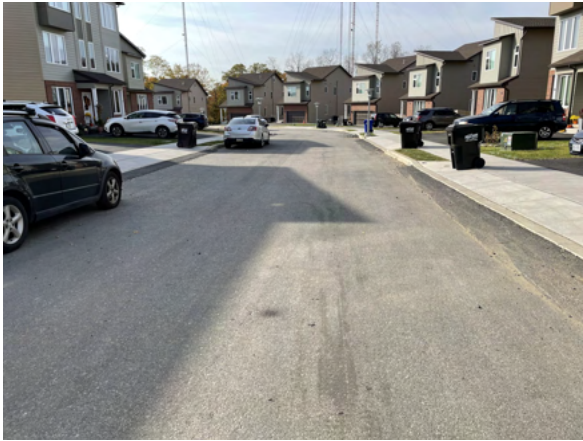
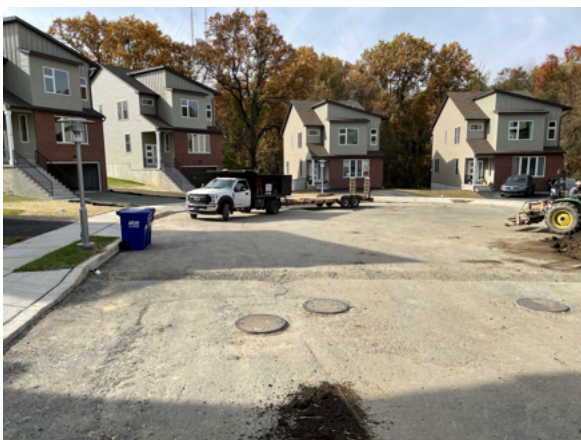
- The asphalt roadway had not yet received its final layer of asphalt from the developer at the time of the site visit. Recommend asphalt surfaces to be completed prior to developer turnover.
- Several areas of damaged concrete curbing and sidewalk were observed on site. See the table on Page 28 for a list of the concrete damage details and locations. Recommend proper repair or replacement to the damaged sections of concrete prior to developer turnover.
- The aluminum fence at the park on the north/northwest property line (closest to homesite 40) will be moved six feet further out to align with the existing wood fence as it was determined that the Association property line had been encroached upon by the neighboring property.
- Three sections of aluminum fencing at the park are damaged; recommend replacement of damaged

View of community - asphalt road

Community view - asphalt road

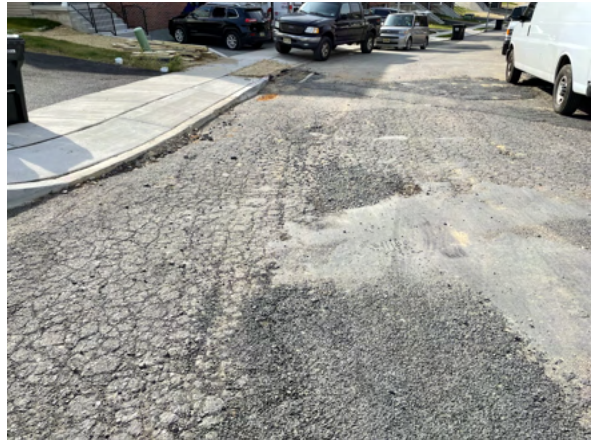
- The asphalt basecoat in front of homesite 15 and the proposed rain garden is damaged. Damage is assumed to be caused by water intrusion and heavy construction vehicles. Recommend properly repairing the basecoat of asphalt prior to installing the final layer of asphalt prior to developer turnover.

Damage to asphalt base at homesite 15

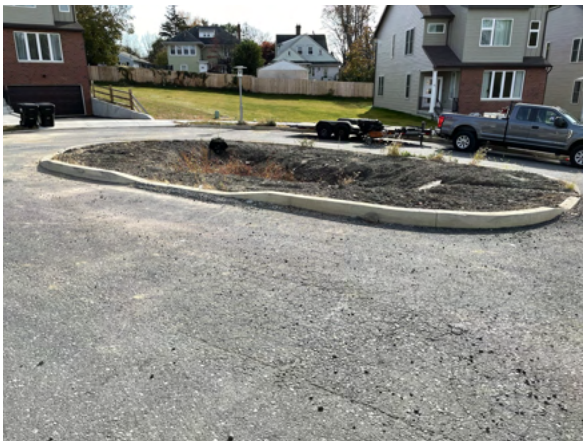
- A rain garden is planned for the "traffic circle" area in front of homesites 12 through 15; per information provided by the client, the rain garden will be installed in the spring of 2022. The concept of the rain garden is to allow the water to percolate into the soils under the rain garden with an overflow in the event excess water fills the rain garden.

Location of proposed rain garden

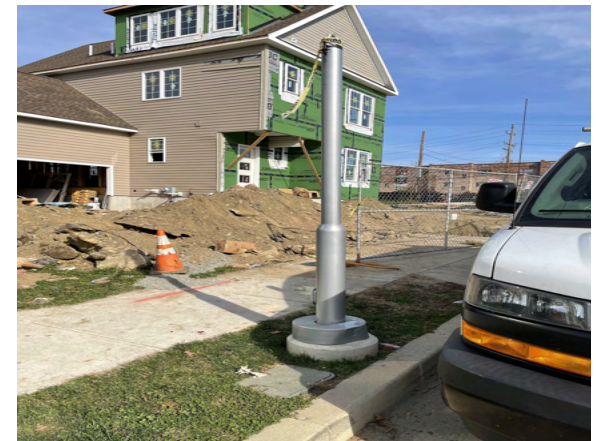
- The street light pole between homesites 30 and 40 is damaged and the lighting fixture is missing; replace the entire unit prior to developer turnover.

Missing light post top

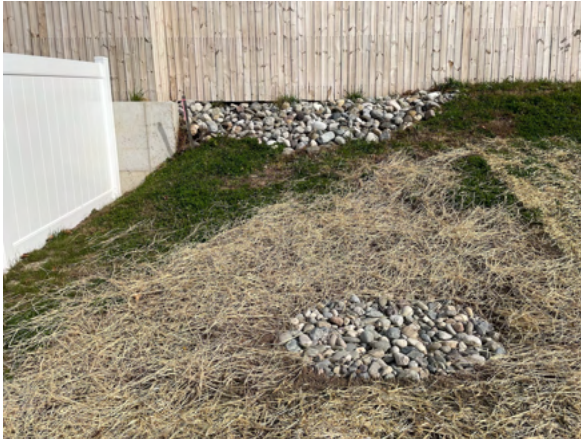
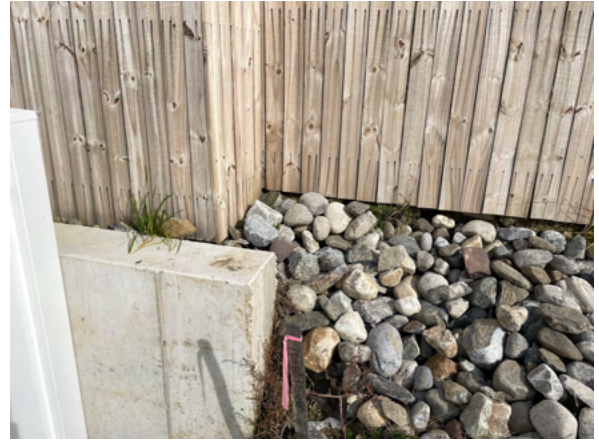
- The soil behind the retaining wall at homesite 13 has settled/eroded should be properly backfilled and compacted to match the existing grade prior to developer turnover.

Rip-rap/drainage issues at homesite 13

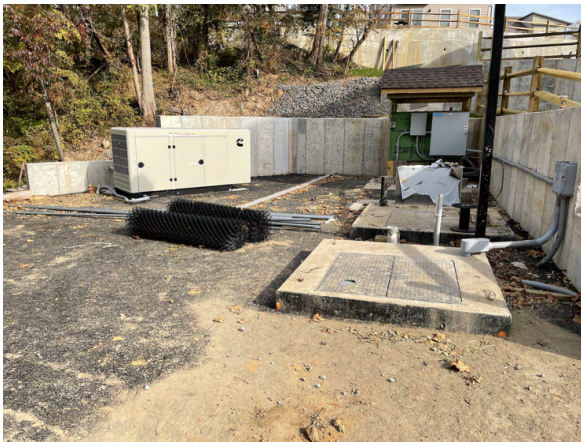
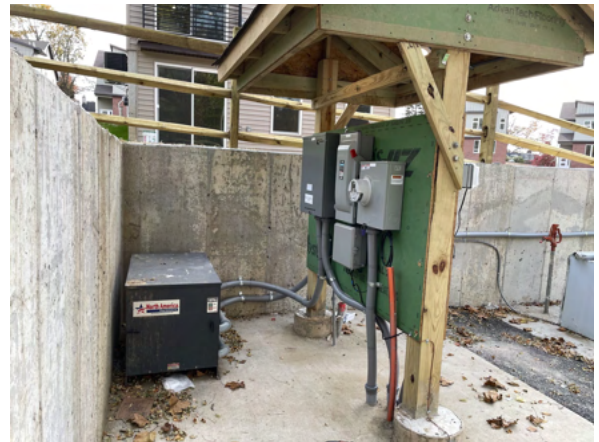
Lift station equipment

- Recommend installing a lock on the sewer lift station area water bib to prevent vandalism (being turned on and left running) prior to developer turnover.

- Recommend evaluation of lift station by a qualified contractor to verify proper operability prior to developer turnover.
- A section of asphalt driveway at homesite 31 is settling at the garage concrete; recommend properly repairing settling asphalt. Recommend developer coordinate with the homeowner to arrange for proper repairs.

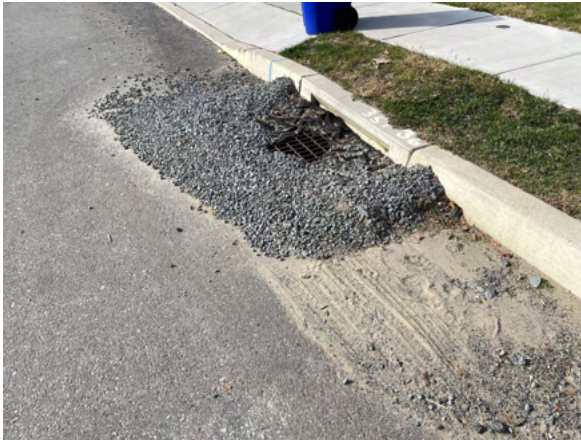
- Storm drains along the asphalt street are clogged with rocks and construction debris; clear storm drains prior to developer turnover.
- All items noted above are accurate as of the date and time of the site visit. Additional assets may require repair/installation should damage occur after the site visit.

Typical storm drain

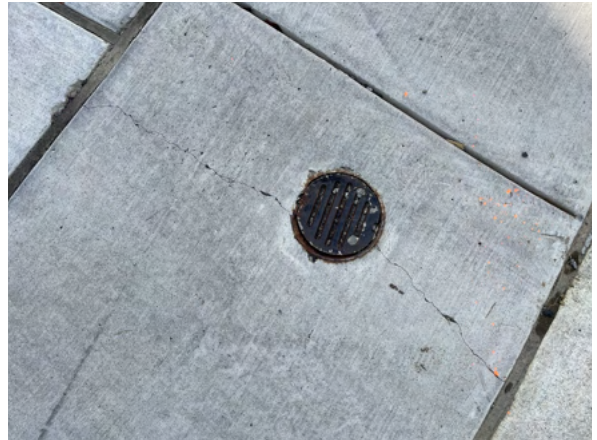
- Four-inch cast iron sewer vents are embedded in the concrete driveway aprons. Concrete was observed at several of the drains' grates. Recommend removing the excess concrete and testing the vents to ensure proper operation prior to developer turnover.

Typical driveway apron sewer vent

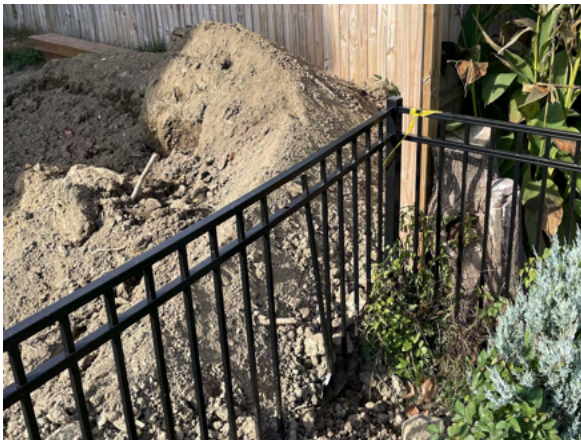
Damage to aluminum park fence

sections of fencing prior to developer turnover.

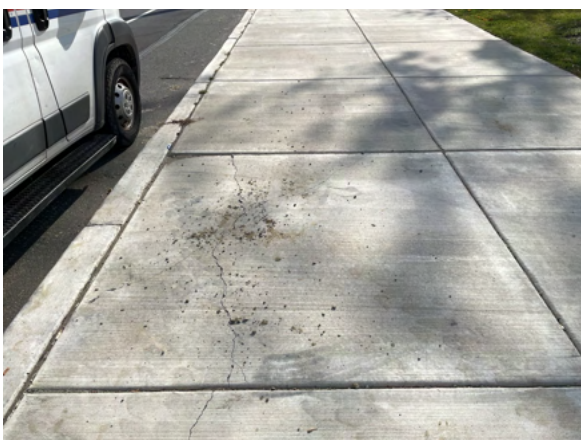
Cracks in concrete - entrance by homesite 1

Location	Issue
Entrance	Eight concrete squares are cracked/damaged at the left side entrance.
Entrance	Two concrete squares are cracked/damaged at the south side of the entrance approximately 30' from homesite 1.
Homesite 1	Curbing at driveway is damaged.
Homesites 1 & 2	Gouges and cracks were noted in sidewalk between homesites 1 and 2.
Homesite 3	Fill cracks at curbs in front of homesite 3.
Homesite 5	Cracks in concrete driveway apron.
Homesite 5	The edge of the asphalt driveway is uneven.
Homesite 7	The corner of the asphalt driveway where it meets the concrete has settled.
Homesite 8	Concrete curbing damaged/broken.
Homesite 8	Several cracks/chips breaks in the concrete curbing along asphalt roadway require repair.
Homesite 9	Concrete curbing damaged/broken.
Homesite 13	Concrete curbing damaged/broken.
Homesite 15	Concrete curbing damaged/broken.
Homesite 15	Concrete at entrance to driveway apron is cracked/damaged.

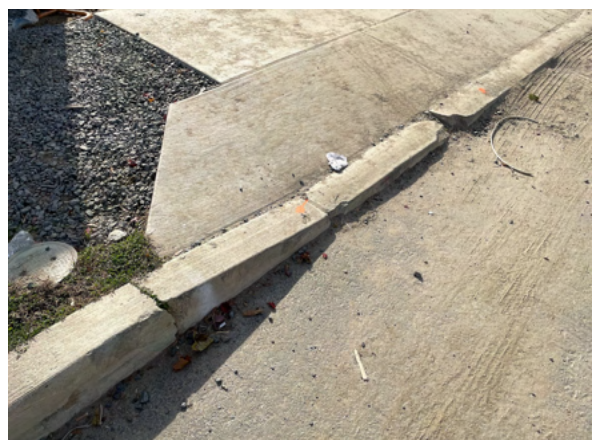
Example of broken concrete at driveway apron

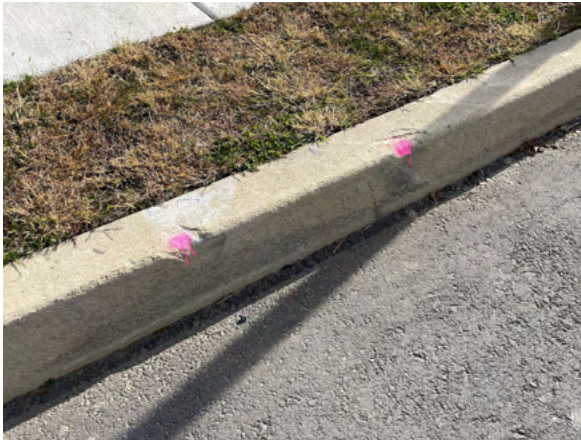
Chips at curbing

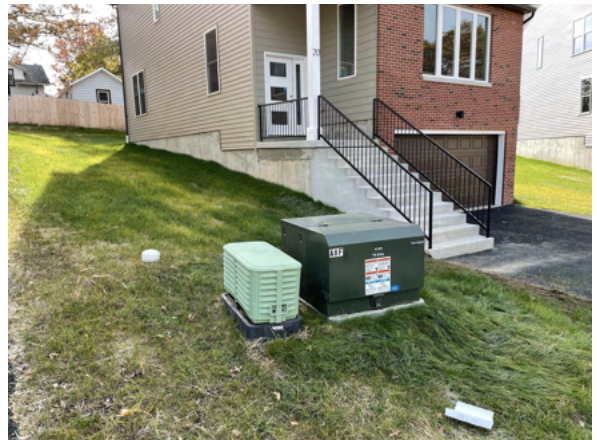
- The grading around the utility boxes at the easement between homesites 19 and 20 should be completed prior to developer turnover.
- The entire lift station and its components require full installation (ie: gas line and meter for generator, phone line, fencing, and gate) as well as testing of the components' alarms prior to developer turnover.

Grading needed at utility boxes

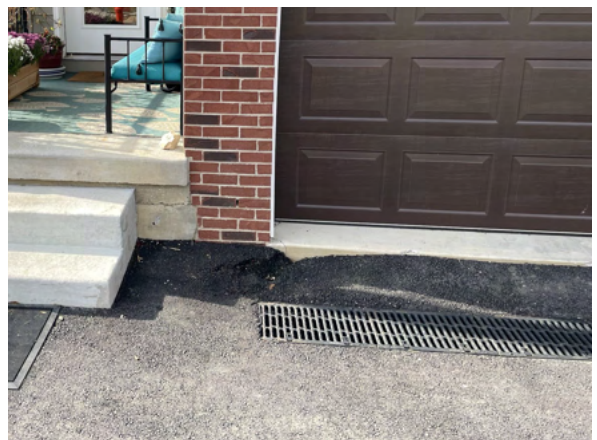
Driveway settlement - homesite 31
